**PROJECT CHECO REPORT**

**ATTACK AGAINST  
TAN SON NHUT**

**8 JULY 1966**

**HQ PACAF  
Tactical Evaluation Center**

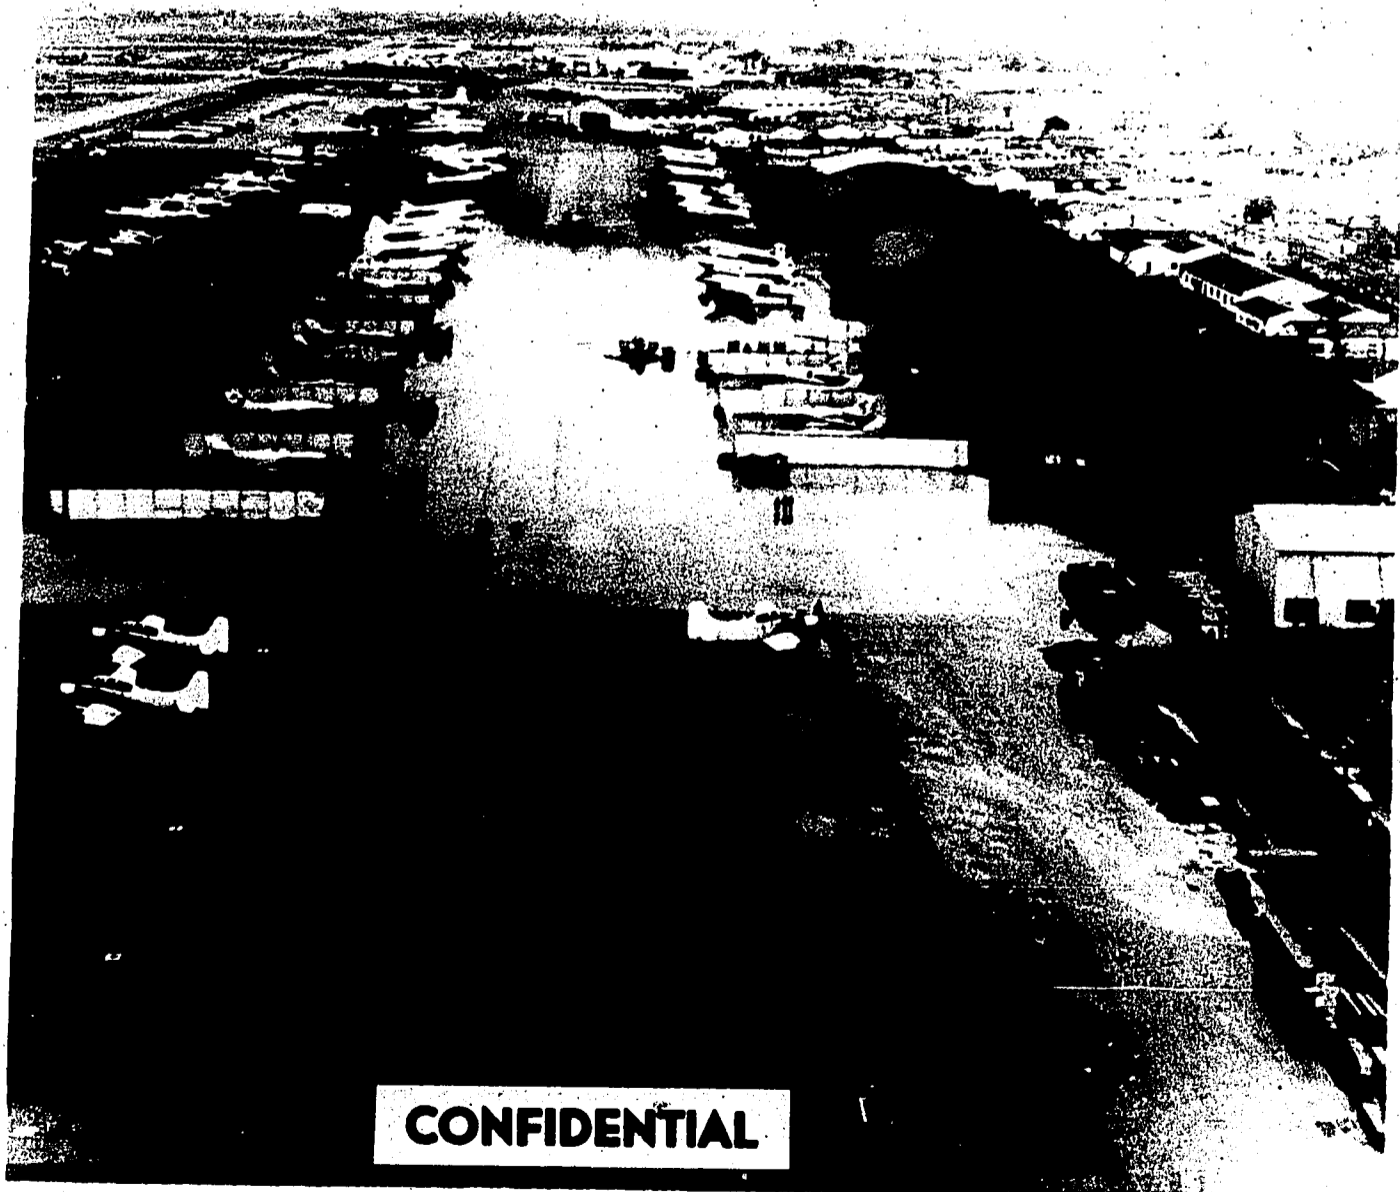
**AERIAL VIEW OF TAN SON NHUT AIR FIELD SHOWING SOME  
REVTMENTS FOR AIRCRAFT PROTECTION**

Nhut Base Commander, replied that the primary reason was the pinpoint accuracy of the attack. He pointed out that the revetments were effective in absorbing some hits and preventing the spread of damage between aircraft parked in revetments. A solution would be increased dispersal between revetments. Colonel Budway pointed out, however, that "limited space at Tan Son Nhut for parking aircraft precludes any immediate accomplishment in this area."<sup>44/</sup>

Of the aircraft damaged during the attack, twenty-three were in revetments. Thirty-nine other aircraft in revetments were not damaged. Eighteen rounds were received within revetment enclosures, while twenty-three rounds hit immediately in front of revetment enclosures. Fifty-eight rounds were delivered in the immediate area of the revetted aircraft, representing approximately twenty percent of the total mortar hits on the base.<sup>45/</sup>

Colonel B. R. Muldoon, Assistant Deputy for Operations, 7th Air Force, pointed out that "the hits suffered by aircraft in the revetments could only have been prevented by covered revetments with steel doors. Two fighters are parked in each revetment space, thus each hit in or in front of the revetment enclosures normally results in two damaged aircraft. A round landing immediately in front of the wall separating the two revetment enclosures can and, in some cases, did damage four aircraft."<sup>46/</sup>

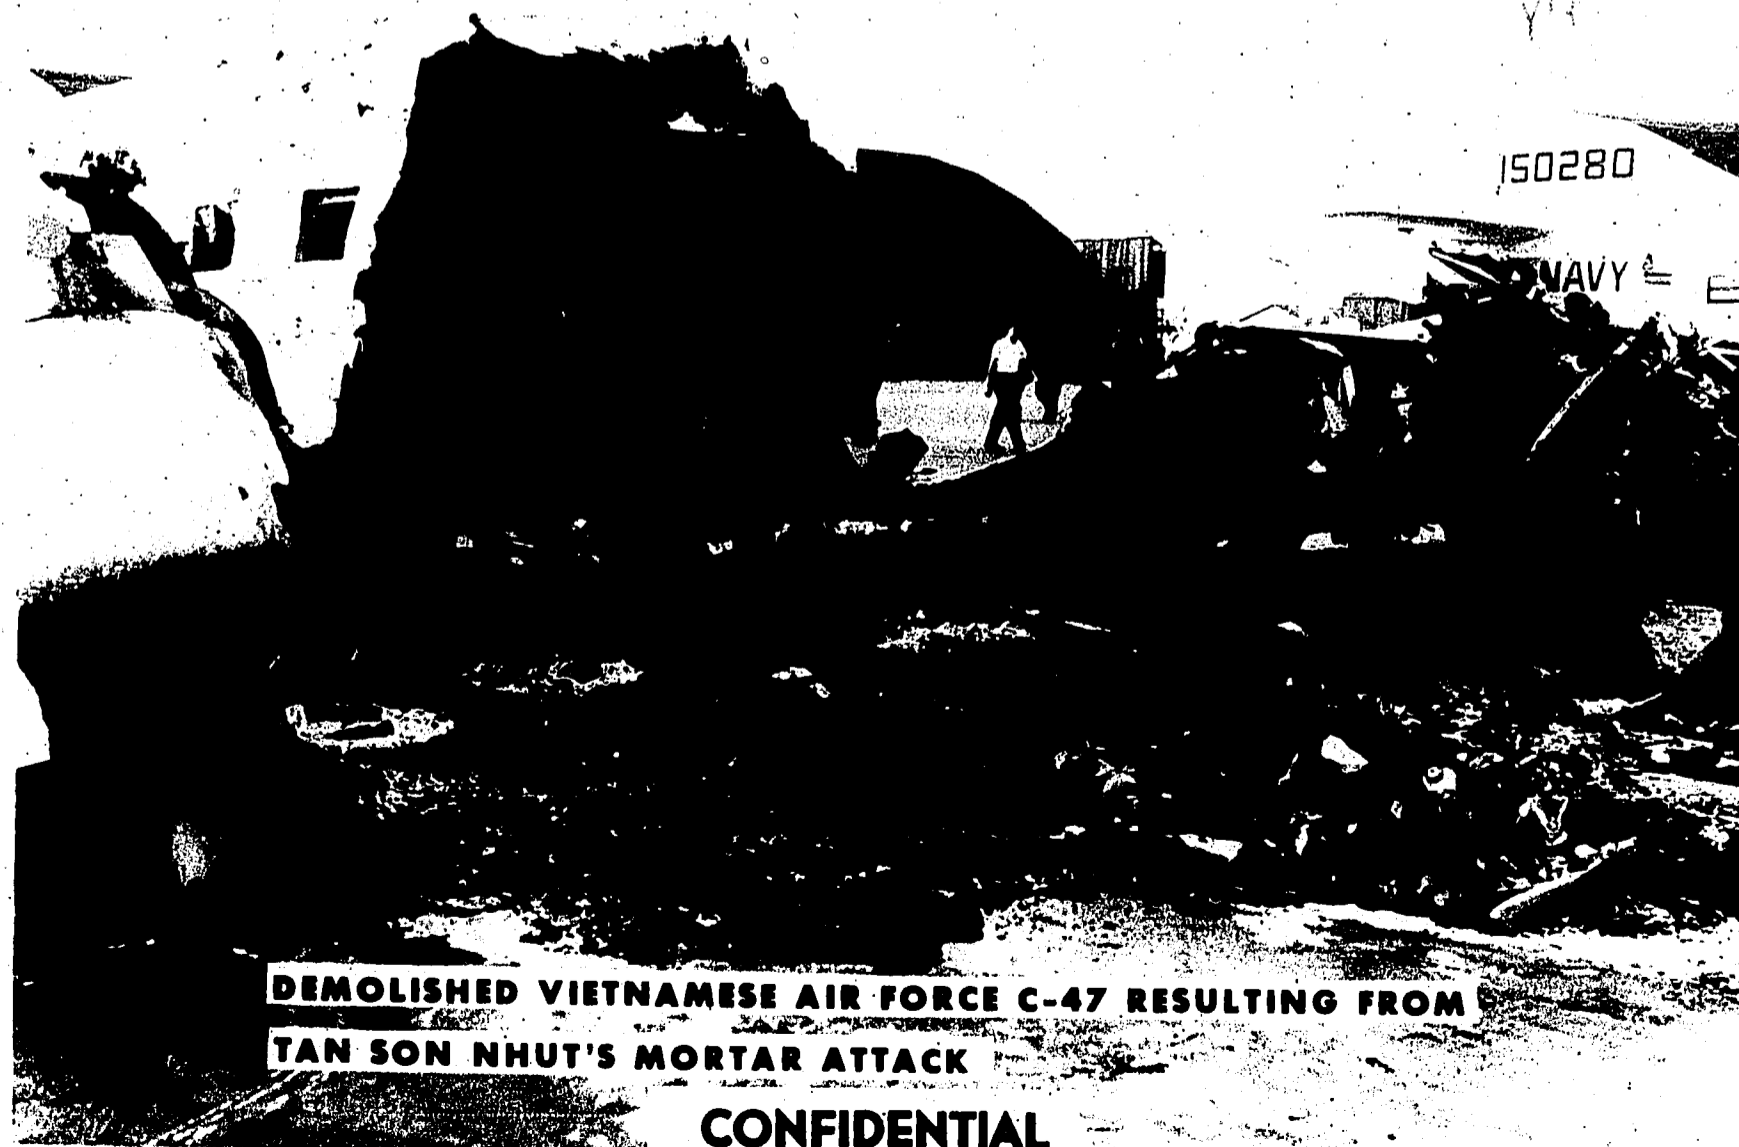
**DEMOLISHED VIETNAMESE AIR FORCE C-47 RESULTING FROM  
TAN SON NHUT'S MORTAR ATTACK**

Two RF-4C's parked in revetments suffered direct hits from mortar shells, two Vietnamese C-47 aircraft were destroyed, and sixty-one USAF aircraft were damaged. <sup>26/</sup>

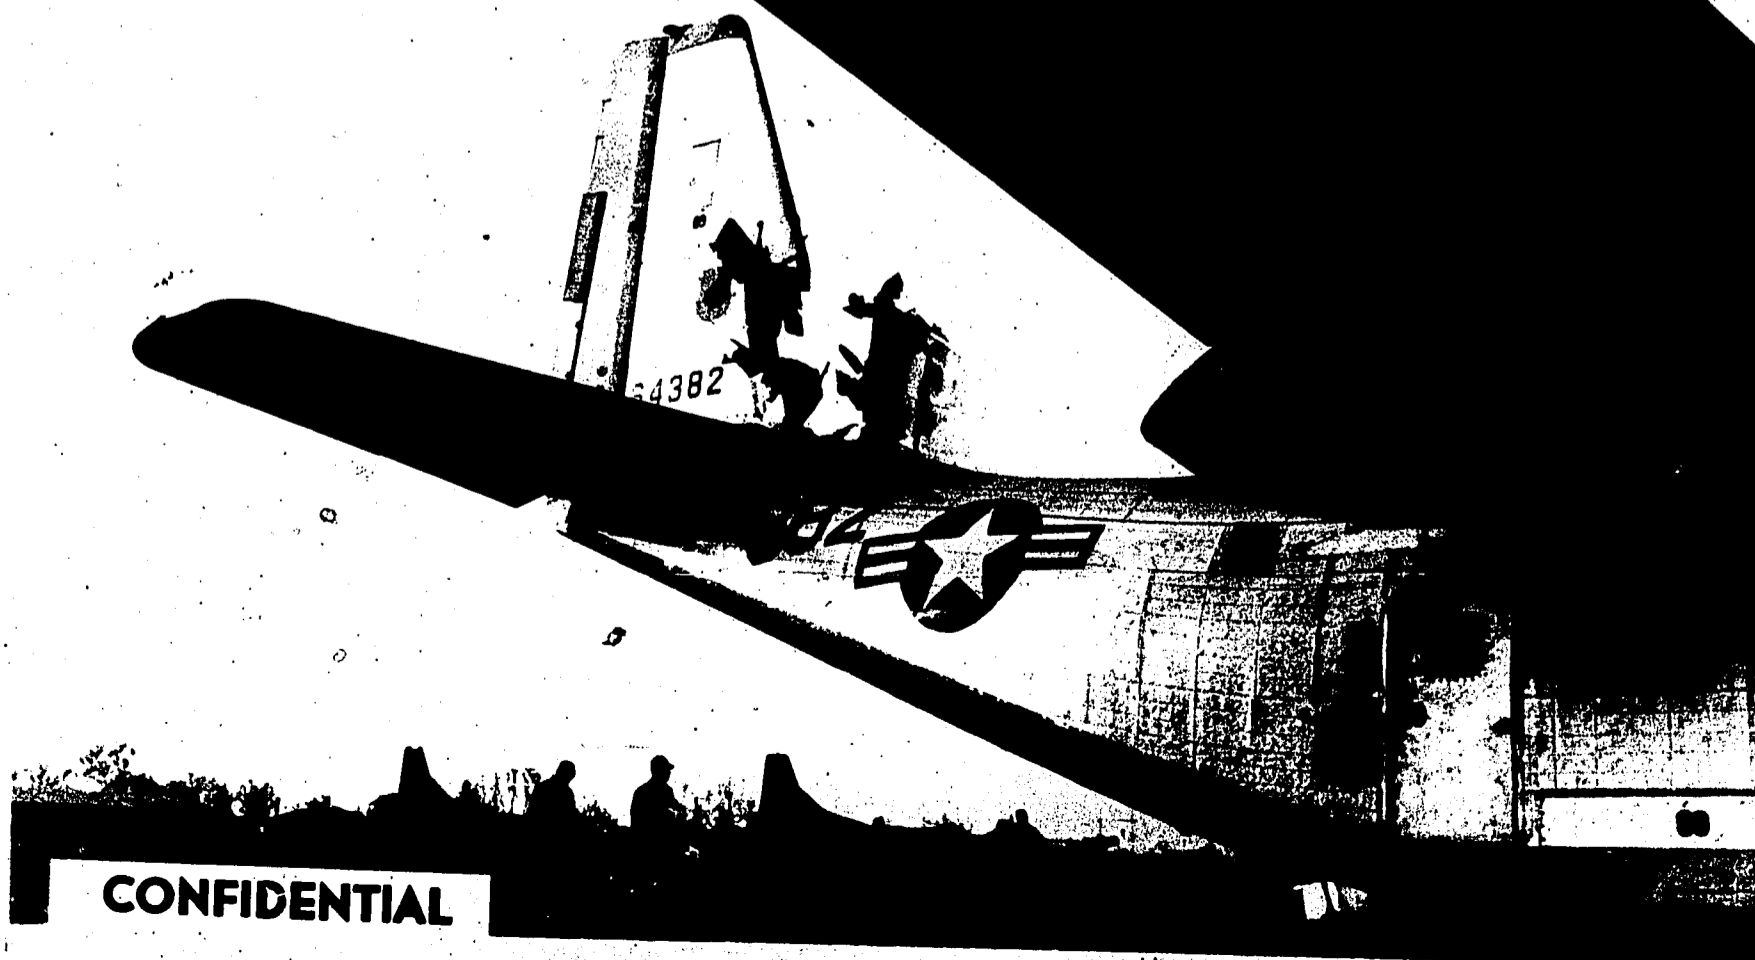
**TAIL SECTION DAMAGE TO USAF C-123 FROM DIRECT HIT  
DURING MORTAR ATTACK ON TAN SON NHUT**

The pinpoint accuracy of the barrage caused considerable damage to aircraft at Tan Son Nhut. In some cases there were direct hits, in other instances the mortar shells landed directly in front of the revetted aircraft and many small pieces of shrapnel penetrated the aircraft. <sup>25/</sup>
